TENNESSEE STATE DEPT OF CONSERVATION NASHVILLE DIV 0--ETC F/6 13/13
NATIONAL PROGRAM OF INSPECTION OF NON-FEDERAL DAMS, TENNESSEE. --ETC(U)
SEP 81 W E BUSH

<table><tr> <td>Dams</td> <td>Sumner County, TN</td> </tr><tr> <td>Portland City Lake Dam, TN</td> <td>Structural Analysis</td> </tr></table>

PHASE I INSPECTION
PORTLAND CITY LAKE DAM
SUMNER COUNTY, TENNESSEE

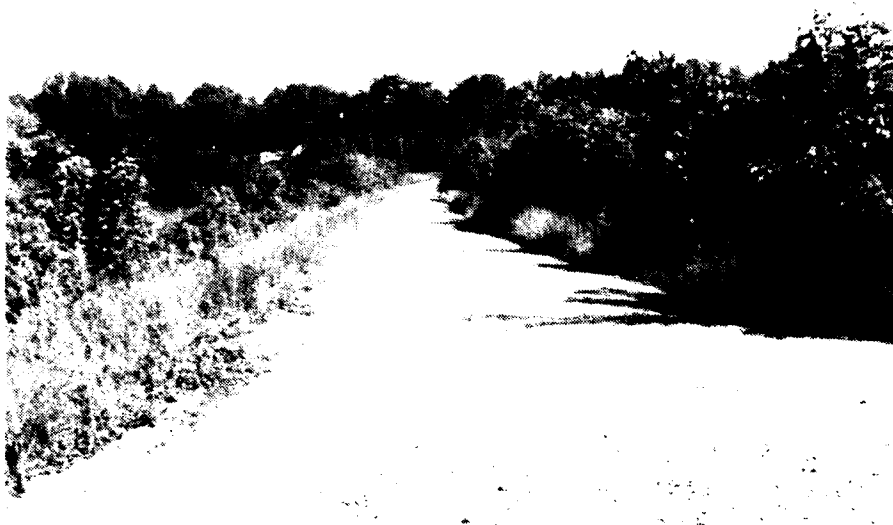
1. Top of Portland City Lake Dam looking north.

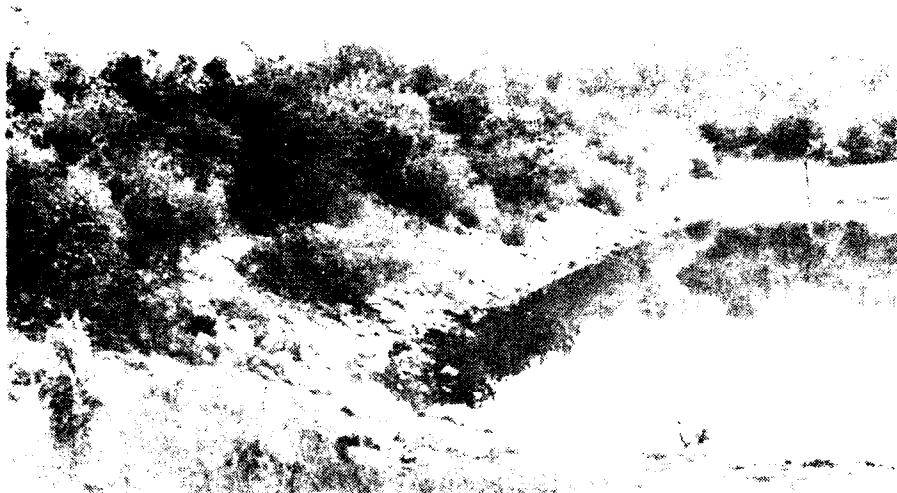
3. Upstream slope of Portland City Lake Dam. Note undesirable vegetation on slope.

- a. Plan and supervise the removal of all trees and underbrush from both slopes of the dam.
- b. Determine if unsafe conditions exist on both slopes of the embankment after removal of the trees and underbrush and design and supervise construction of remedial measures to provide a safe embankment.

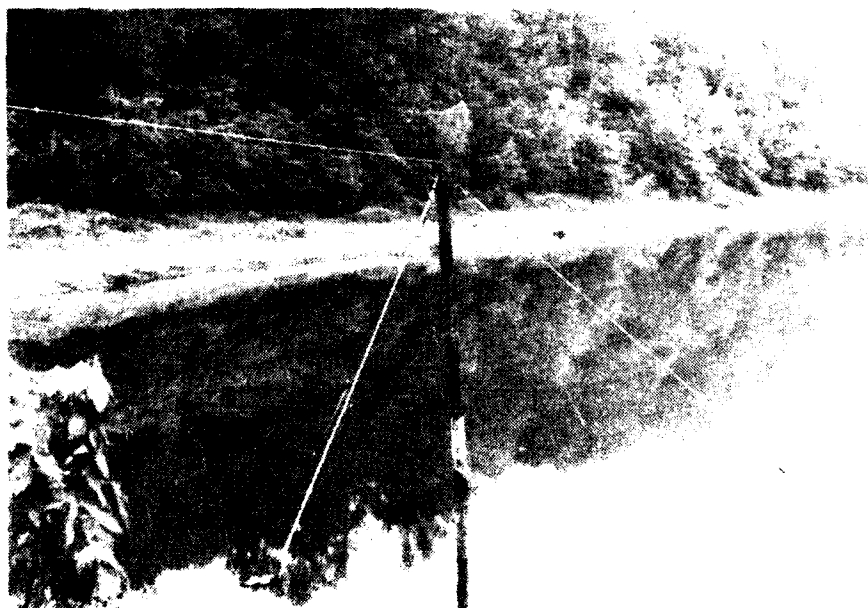
4. Pipe supporting cable left for raw water intake valve.

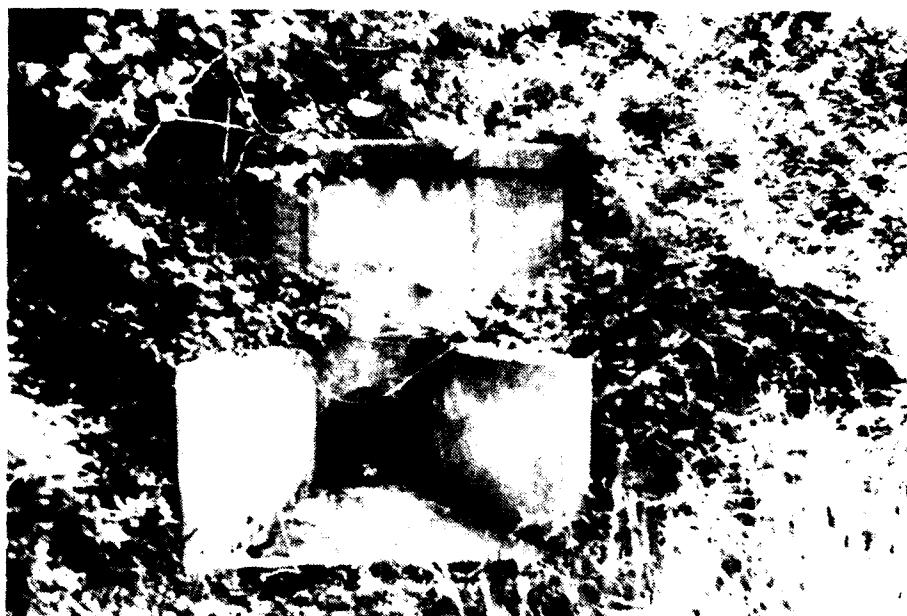
Near the water works, and about Station 3 + 20, the discharge end of the drawdown conduit is located below the toe of the slope at elevation 661.7. This is a 16 inch diameter CI pipe set in concrete, with a control valve. (See Photo 5). The discharge channel flows over thin-bedded limestone, undermined at the level of the small pool below the outlet. In the channel area freshly broken fragments of rock float. The channel is covered with grass and is reasonably clear and discharges into a stream to the east.

- g. The valve for the 16 inch drawdown pipe is located at the downstream end of the pipe thereby maintaining pressure within the pipe at all times and increasing the possibility of failure of both the pipe and fill.

5. Drawdown pipe outlet and valve located at downstream toe of Portland City Lake Dam.

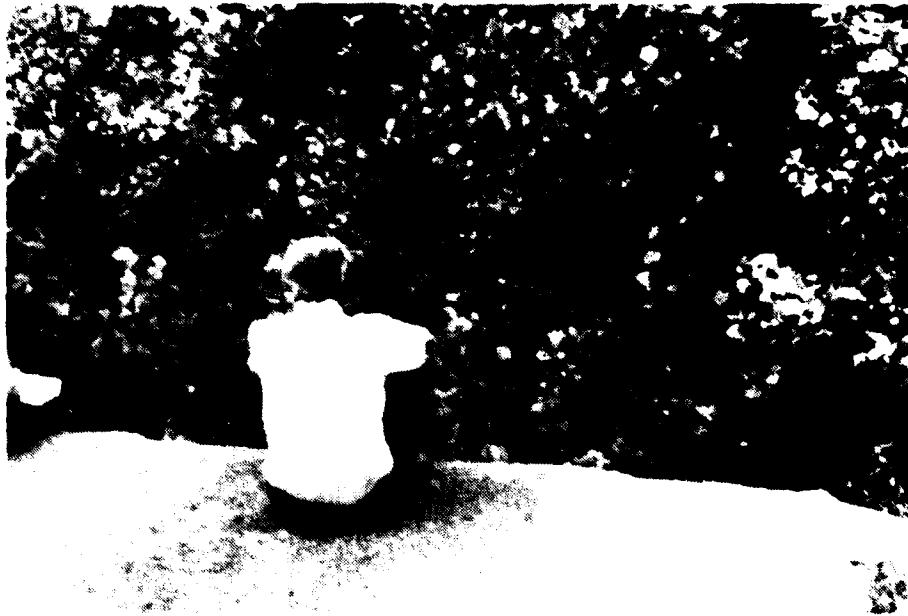
9. Downstream end of emergency spillway chute. Note overfall at end of chute.

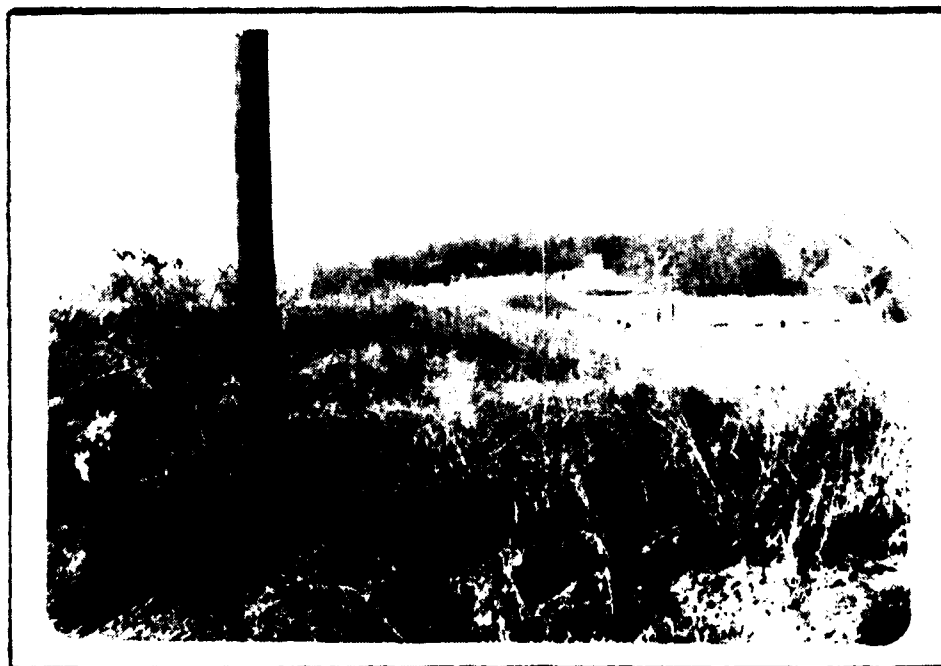
PHOTO NO. 8

- Photo No. 8 - View of leakage and undermining under the concrete spillway exit channel.
- Photo No. 9 - View of a boil type leak below the dam in the spillway exit channel.
